# NATIONAL ADVISORY COMMITTEE FOR AERONAUTICS

No. 1095

MARINE EXPOSURE TESTS ON STAINLESS STEEL SHEET

National Bureau of Standards

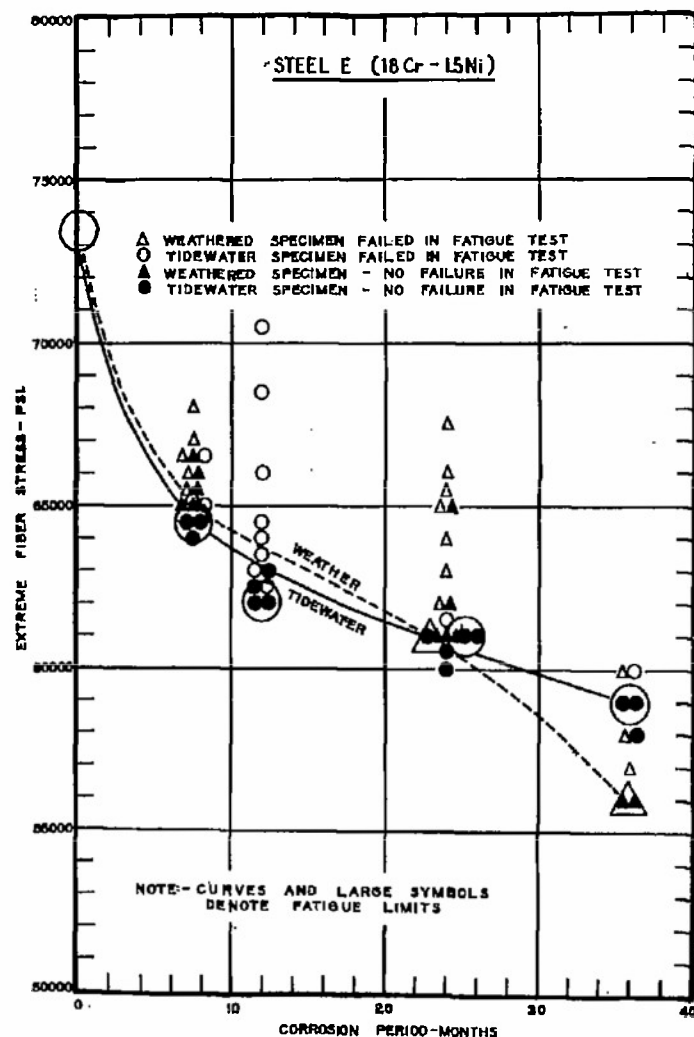
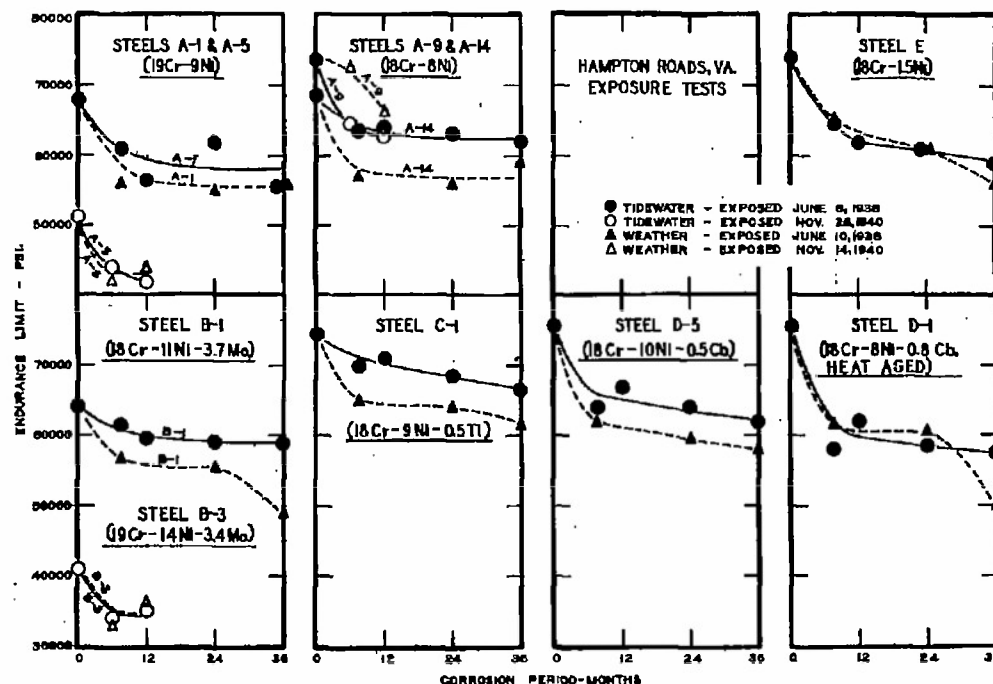
Figure 16.- The charts summarize the data for each of the steels (figs. 9-15, 19-21) exposed at Hampton Roads, Va., and show the loss in fatigue limits as related to the period of exposure. Panels exposed in 1938 were located at Boush Creek, while those exposed in 1940 were located at the Lagoon.

Figure 15.- Results of flexural fatigue tests on Steel E, giving the data for each specimen tested, and the approximate fatigue limits.

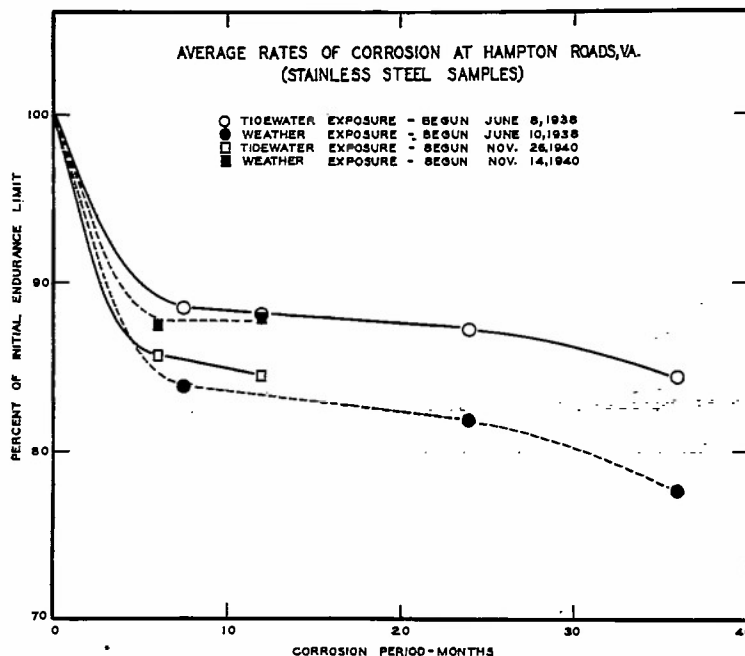
6. The relative susceptibility to corrosion of the particular sheets under the specific conditions of exposure used in these investigations (fig. 17) could be established by fatigue tests. These revealed a superiority in the steels containing molybdenum or titanium, and an inferiority of the heat-aged columbium-bearing steel and one of the 16:1 type. The relatively narrow range of the loss in fatigue limits ( $\pm 5$  percent) for all the steels except the last two, indicated that the order of susceptibility may be expected to show variations, within the ranges established, on different heats of metal exposed under the same, or other marine conditions.

Figure 17.- Panels exposed in 1938 were located at the Boush Creek site, while those exposed in 1940 were located at the Lagoon, at the U.S. Naval Air Station, Hampton Roads, Va. The data are the average for all the stainless steel panels, irrespective of their chemical compositions.

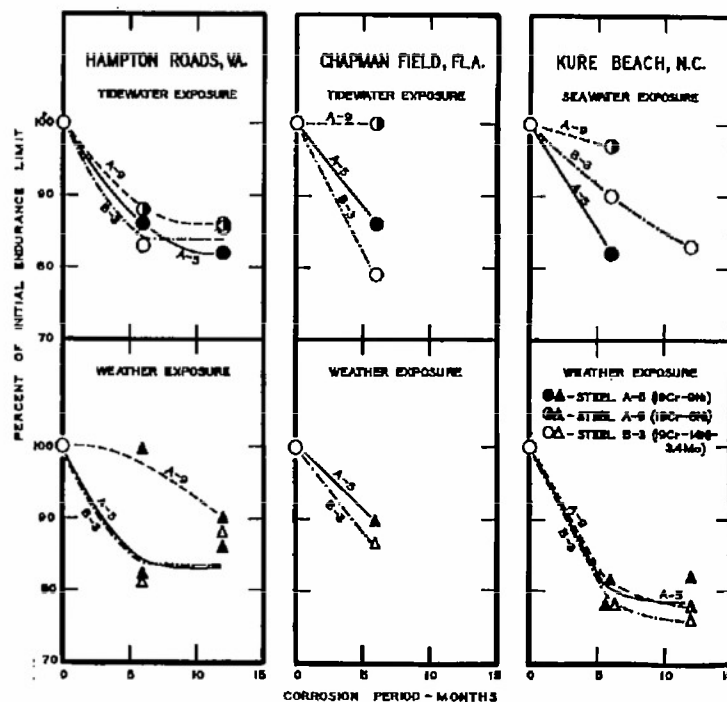
Two straight 18:8 type steels, one (A-9) with a tensile strength of 190,000 psi, and the other (A-5) with 100,000 psi, along with a 1/4-hard-rolled steel (B-3) having a tensile strength of 120,000 psi were exposed simultaneously at the three localities. The fatigue tests (fig. 22) revealed that steel A-9 usually was the least susceptible to corrosion. Steel A-5 was somewhat more resistant to corrosion than steel B-3 under all the conditions of exposure, except in the sea water at Kure Beach, N. C.

Figure 22.- The charts summarize the data for each of the steels exposed simultaneously at the three localities (figs. 19, 20 and 21), and show the loss in fatigue limits as related to the period and type of exposure.

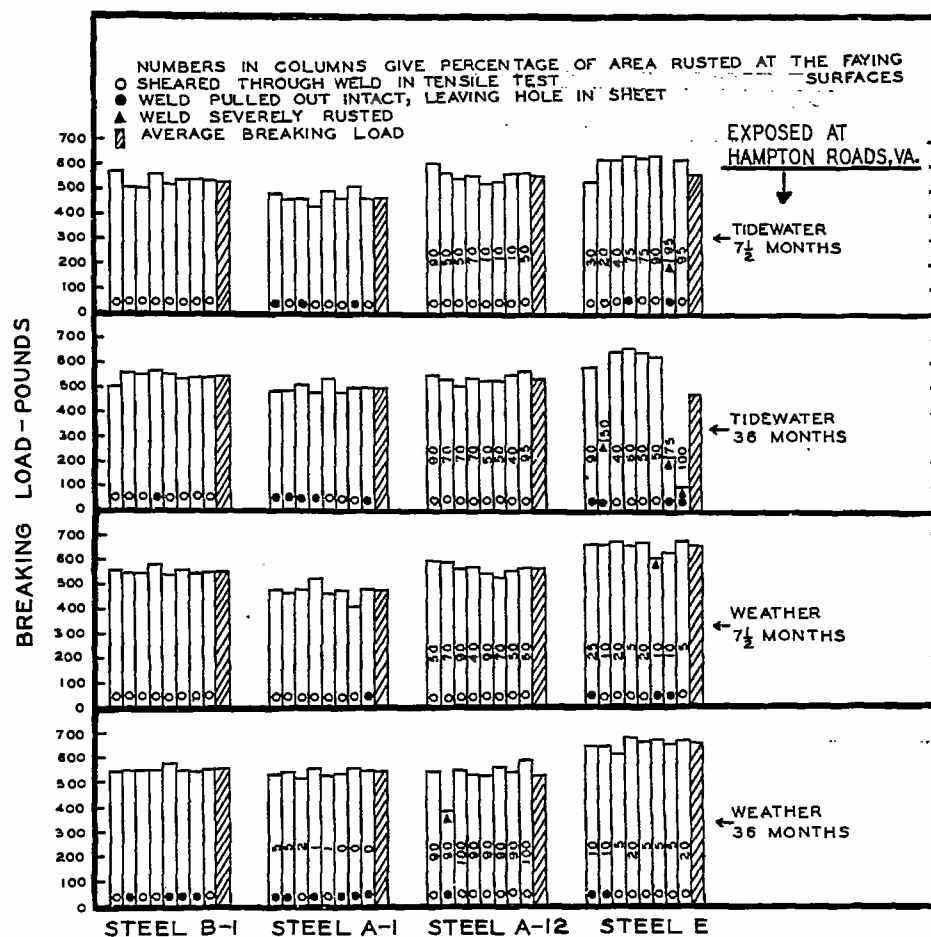
Representative results of the tensile tests on a few of the steels (fig. 24) reveal that, except for isolated instances on corroded welds, the range in breaking loads for the single welds was within narrow limits. The highest values were obtained on steel E. Tests made at the E. G. Budd Manufacturing Company on similar welds in this 16:1 type steel, showed that they would withstand a twist of only  $10^\circ$  before failure; whereas welds in the 18:8 type steels withstood a twist of  $90^\circ$  before failure. Shot welds in alloys corresponding to steel E probably would not prove as satisfactory as the austenitic type alloys for highly stressed structures.

Figure 24.- Results of tensile tests on individual shot-welds from representative panels after exposure at Hampton Roads, Va.

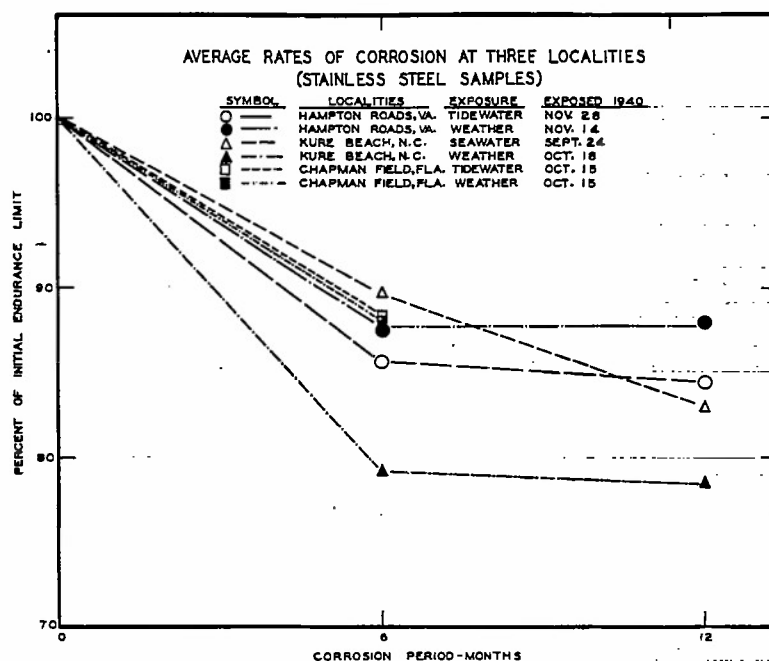
The results of the fatigue tests on panels exposed simultaneously (Steels A-5, A-9, and B-3) at Hampton Roads, Kure Beach, and Chapman Field (figs. 19, 20, 21, and 22) already have been given with respect to the behavior of each steel. The average data for the three steels (fig. 35), plotted on the basis of percent loss of initial endurance limit, reveals more informatively the rates of corrosion as related to

the locality of exposure. Panels exposed to the weather at Kure Beach exhibited more loss in fatigue limits than those exposed under any of the other marine conditions. These curves show that after exposure to weather or tidewater at Hampton Roads or Chapman Field, or after exposure to sea water at Kure Beach, the average variation in the percentage of loss in the fatigue limits was within  $\pm 2\frac{1}{2}$  percent. This compares closely with the value of  $\pm 3$  percent (fig. 17) obtained at the Hampton Roads station on a larger number of specimens initially exposed on a different date.

Figure 35.- The average percentage of loss of endurance limit of stainless steel panels exposed to the weather or tidewater at Hampton Roads and Chapman Field, or to the sea water at Kure Beach is shown to be very similar, the deviation being less than  $\pm 3$  percent. Panels exposed to the weather at Kure Beach were the ones most severely corroded.
